6 Virginia Institute of Marine Science-West, Gloucester County

(Excerpt from "Living Shoreline Sea Level Resiliency: Performance and Adaptive Management of Existing Breakwater Sites, Year 3 Summary" Report)

6.1 Site Background

6.2 Site Performance

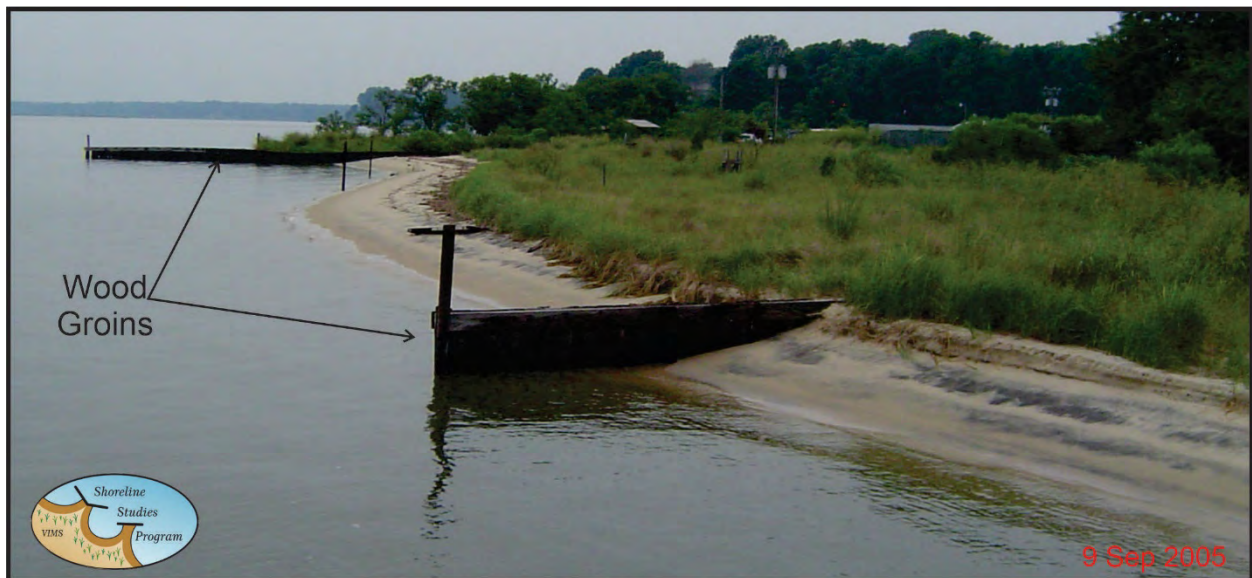
Prior to construction, the VIMS West shoreline was sandy with a low marsh upland (Figure 6-8). Though the shoreline near the point was stable, the upriver section was eroding. After several large storms impacted the VIMS shoreline, funding was received to construct living shorelines on both sides of the VIMS campus. The VIMS West breakwaters and beach fill were placed in September 2010 (Figure 6-9 and 6-10). Beach grasses were planted the following spring (Figure 6-11).

Figure 6-8. The VIMS West coast was a low eroding shoreline with wood groins for shore protection prior to installation of the breakwaters. Photo credit: Shoreline Studies Program, VIMS

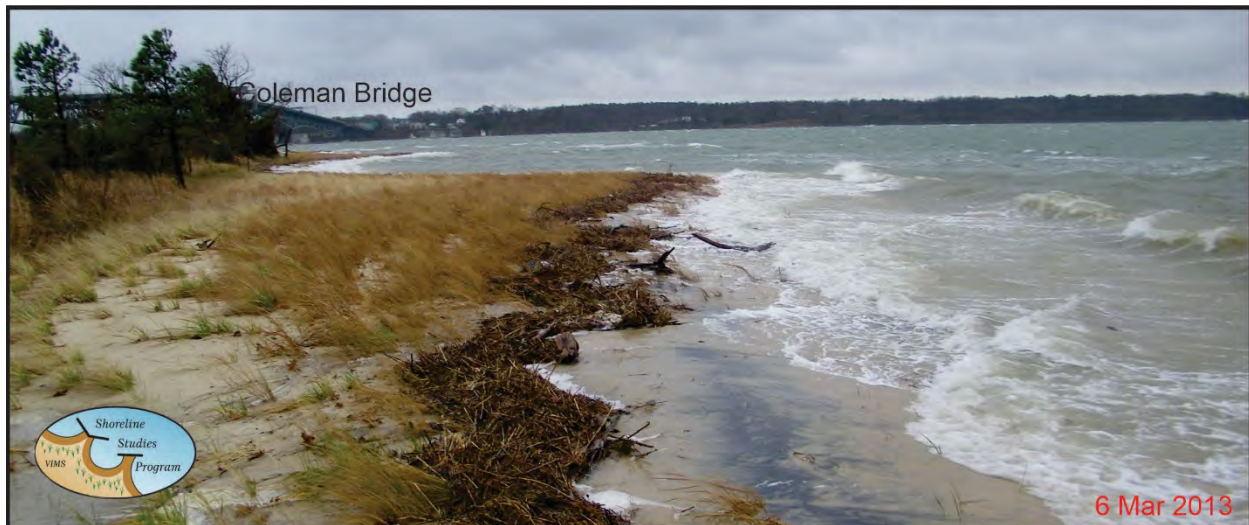
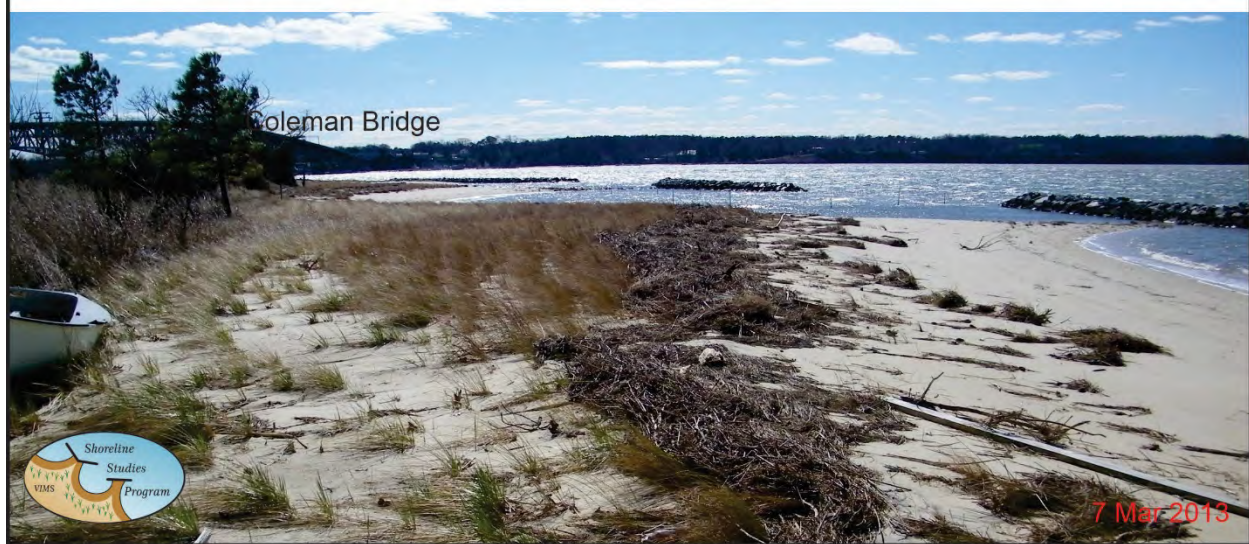
Storms impacted VIMS West after the project was installed, particularly in 2012 (Hurricane Sandy) and in 2013 (March Extratropical Cyclone). As shown in Figure 6-12, water levels completely overtopped the structures at VIMS West. As a result, the subaerial attachment at breakwaters 2 and 3 became narrow. However, maintenance planting and natural marsh vegetation colonized the attachment (Figure 6-13). Over the next six years, natural low marsh vegetation increased behind breakwaters 2 and 3, increasing the width of the attachment (Figure 6-14). In addition, the gabion breakwaters that were uncovered are functioning as semi-detached breakwaters. The channel jetty spur supports that embayment, Bay A.

Figure 6-12. Photos taken at VIMS West during the passage of the March 2013 Northeast storm. Water levels are high enough to overtop the structures, but by the next day, tide levels had dropped. Photo credit: Shoreline Studies Program, VIMS

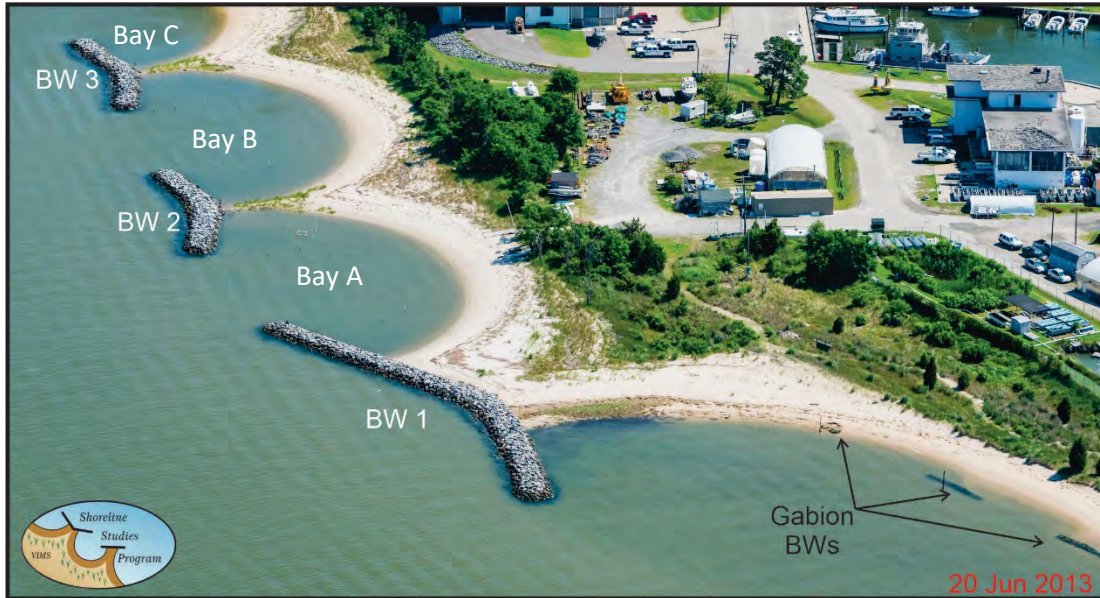
Figure 6-13. Aerial photo taken in June 2013 showing VIMS West 2.5 years after construction.

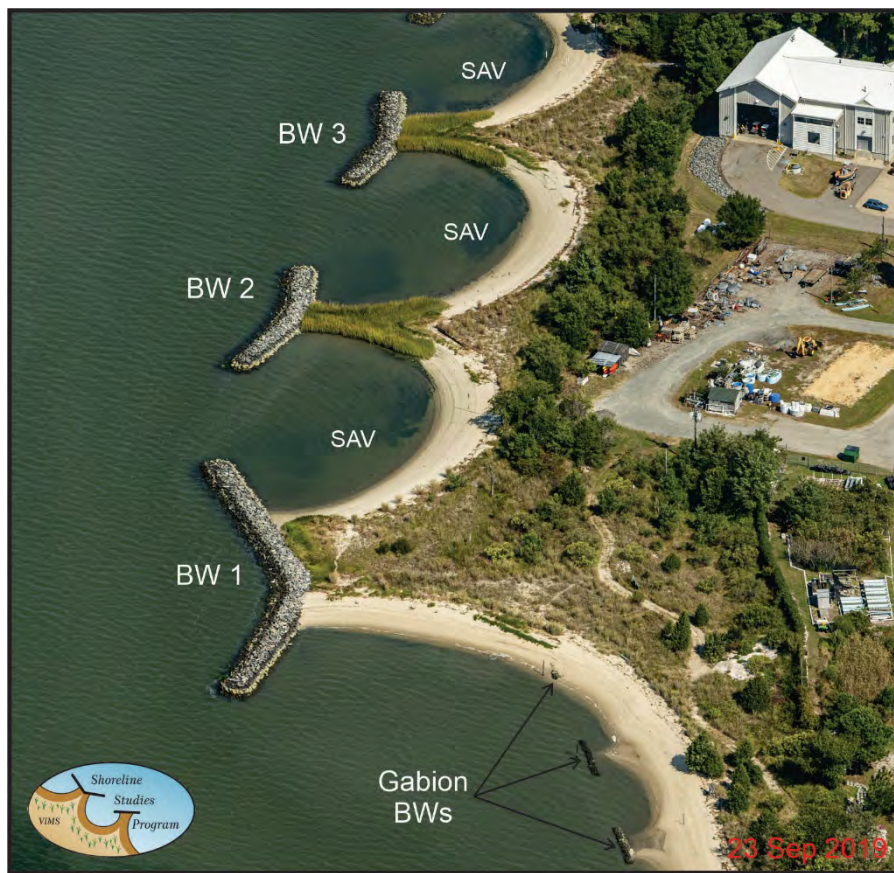
SAV occurs in the embayments. Prior to the installation of the breakwaters, historical SAV records show that the underwater grasses come and go at the site. Yearly records indicate a lack of SAV at the site between 1971 and 1990. After that, patches occurred at the site until 2002 when the nearshore was covered with SAV along the entire site. However, that coverage declined until no SAV existed in 2007. With the construction of the breakwaters in 2010, the opportunity existed for SAV to colonize the shallow embayments between the structures, and presently, a large amount of SAV occurs at the site (Figure 6-14).

Figure 6-14. Aerial photo taken in September 2019 showing VIMS West nearly 9 years after construction.

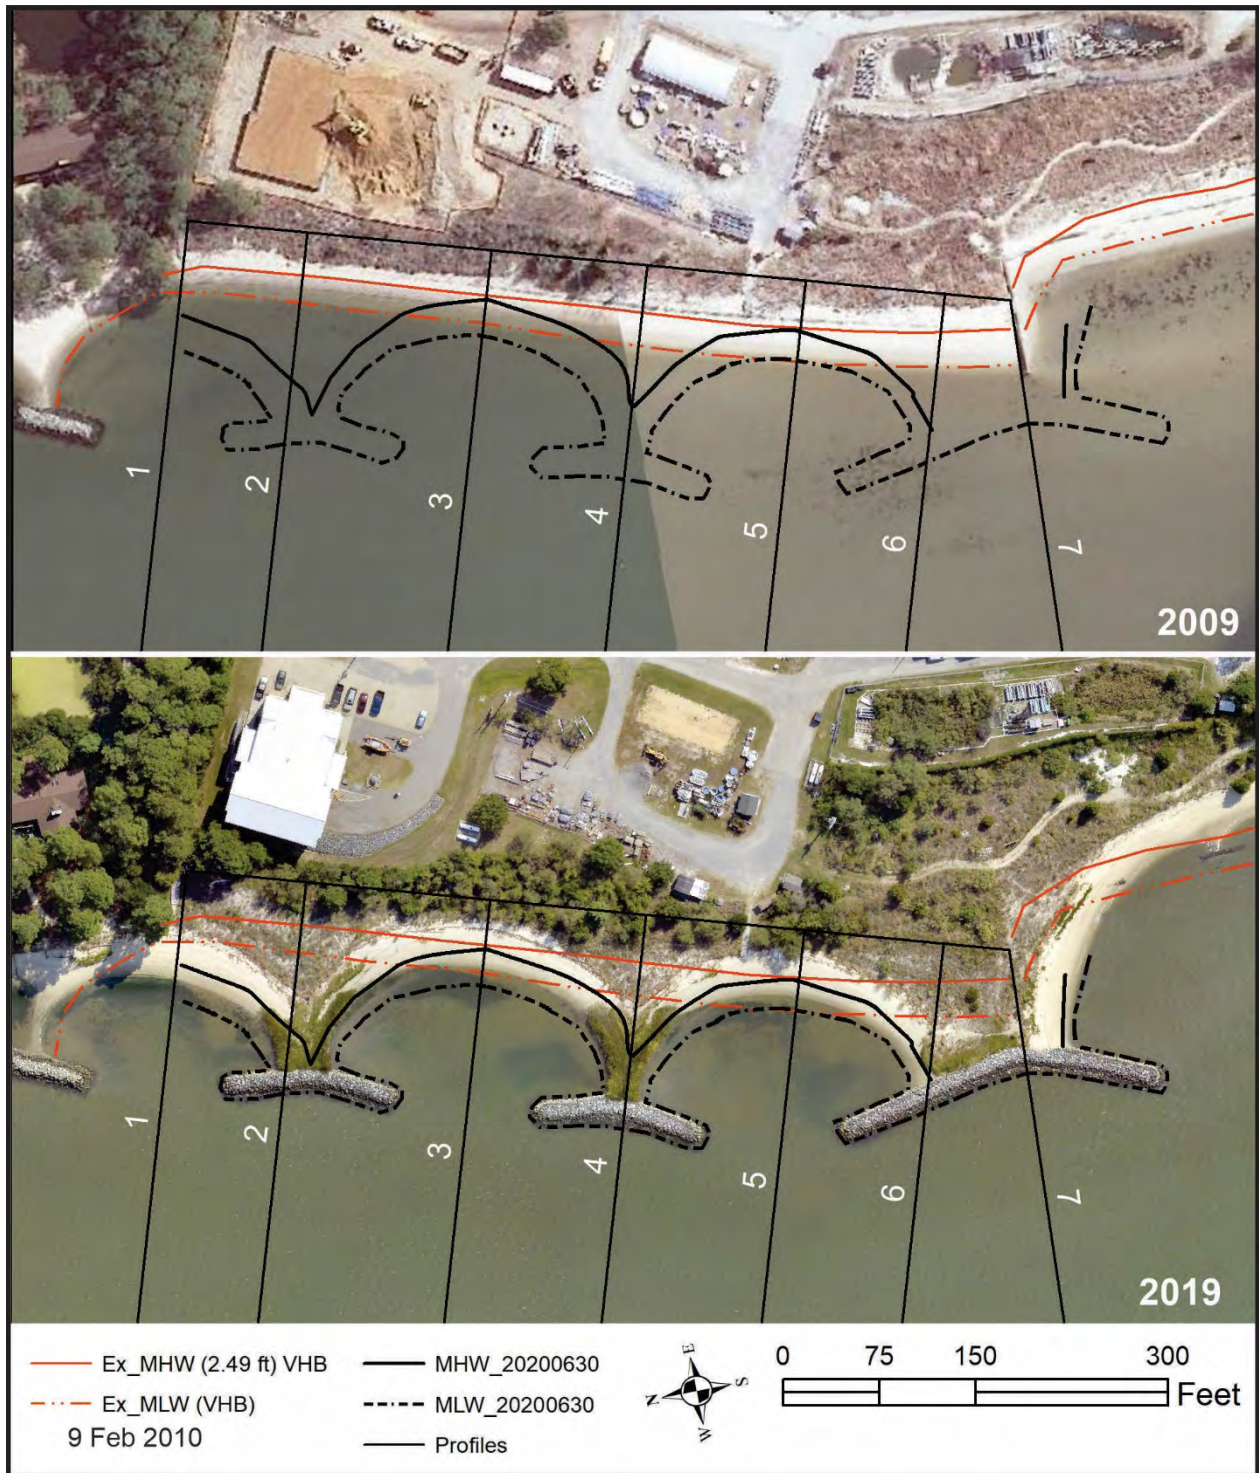
Net change in shoreline position is dramatic pre-post project (Figure 6-15). In some areas, the position of MLW is shifted over 100 ft riverward. The center of the embayments had the least change between pre and post construction. All profiles showed a large volume of sand placed except Profile 5 (Figure 6-16). Since construction, generally, the upriver section of

Figure 6-15. Survey data analysis at VIMS West showing the position of MHW and MLW before construction in February 2010 (VHB survey) and in June 2020, about 9.5 years after construction. Top photo base is 2009 VGIN image, bottom image is SSP's September 2019 image.

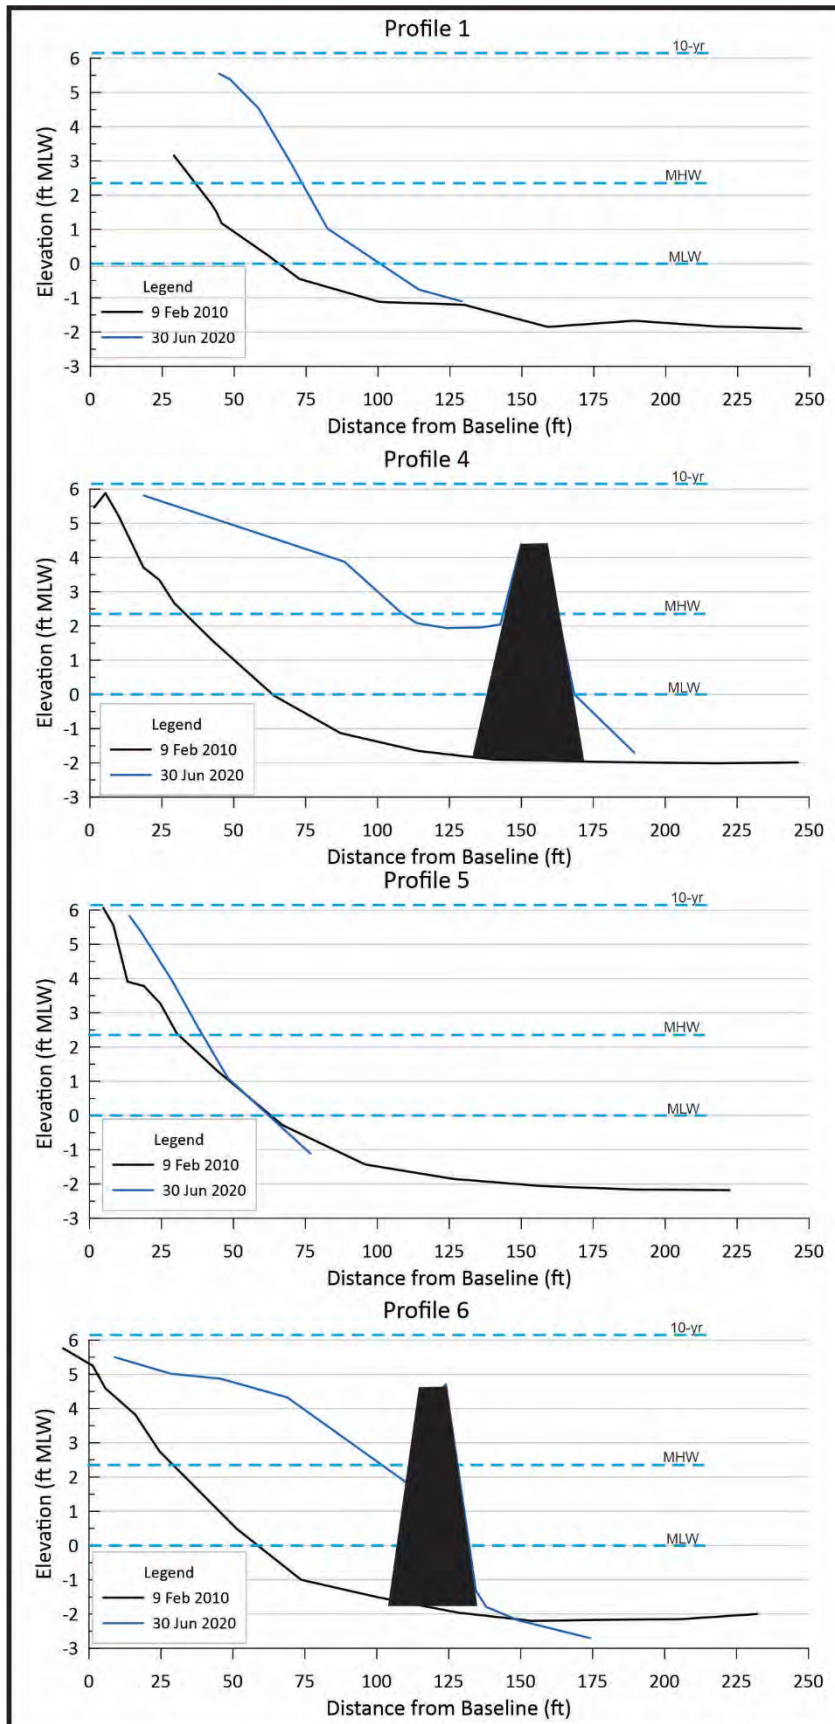
Figure 6-16. Profile data taken in February 2010 (pre-construction, VHB survey) and in June 2020 by SSP.

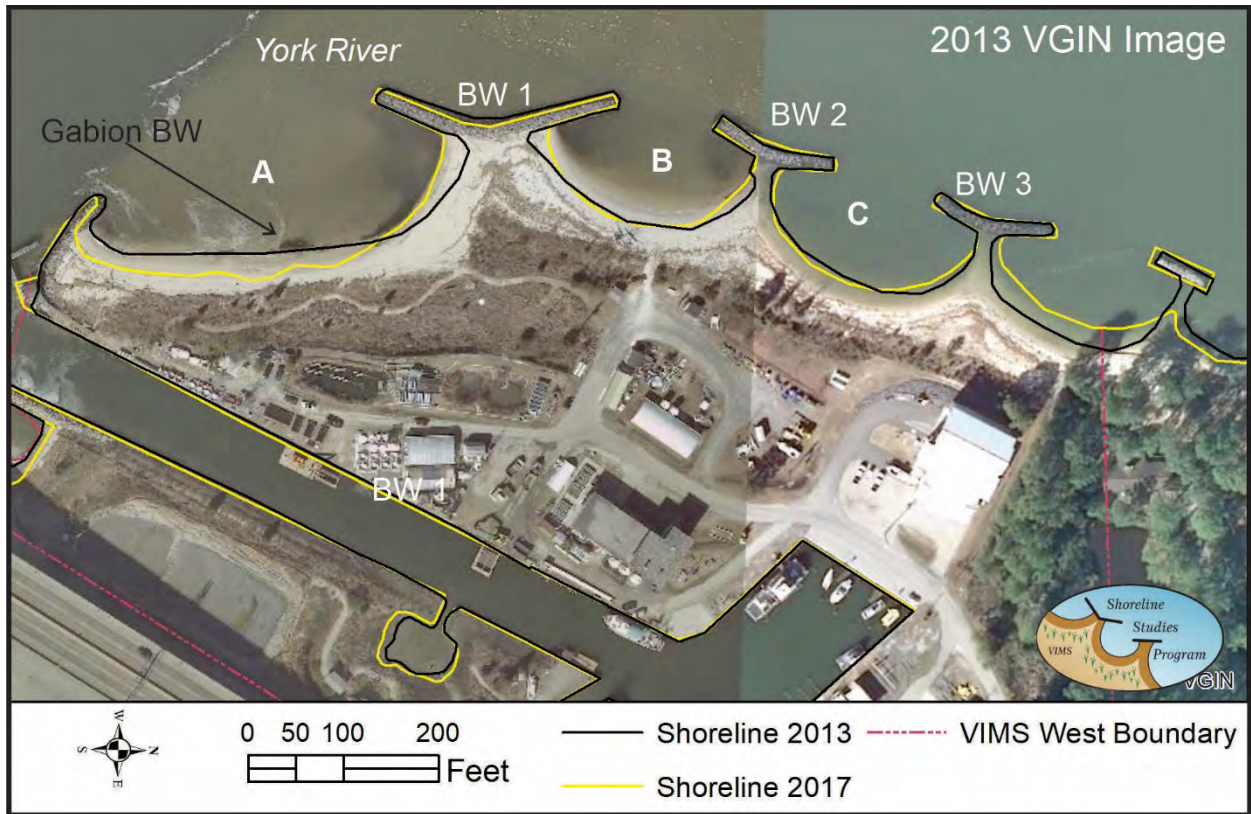
shoreline is accreting (north of BW3), embayments B and C are stable, but embayment A is still equilibrating to its equilibrium position (Figure 6-17). The gabion breakwaters have become uncovered and are influencing the shoreline in embayment A as well.

Figure 6-17. A 2013 VGIN photo showing the 2013 and 2017 digitized shorelines.

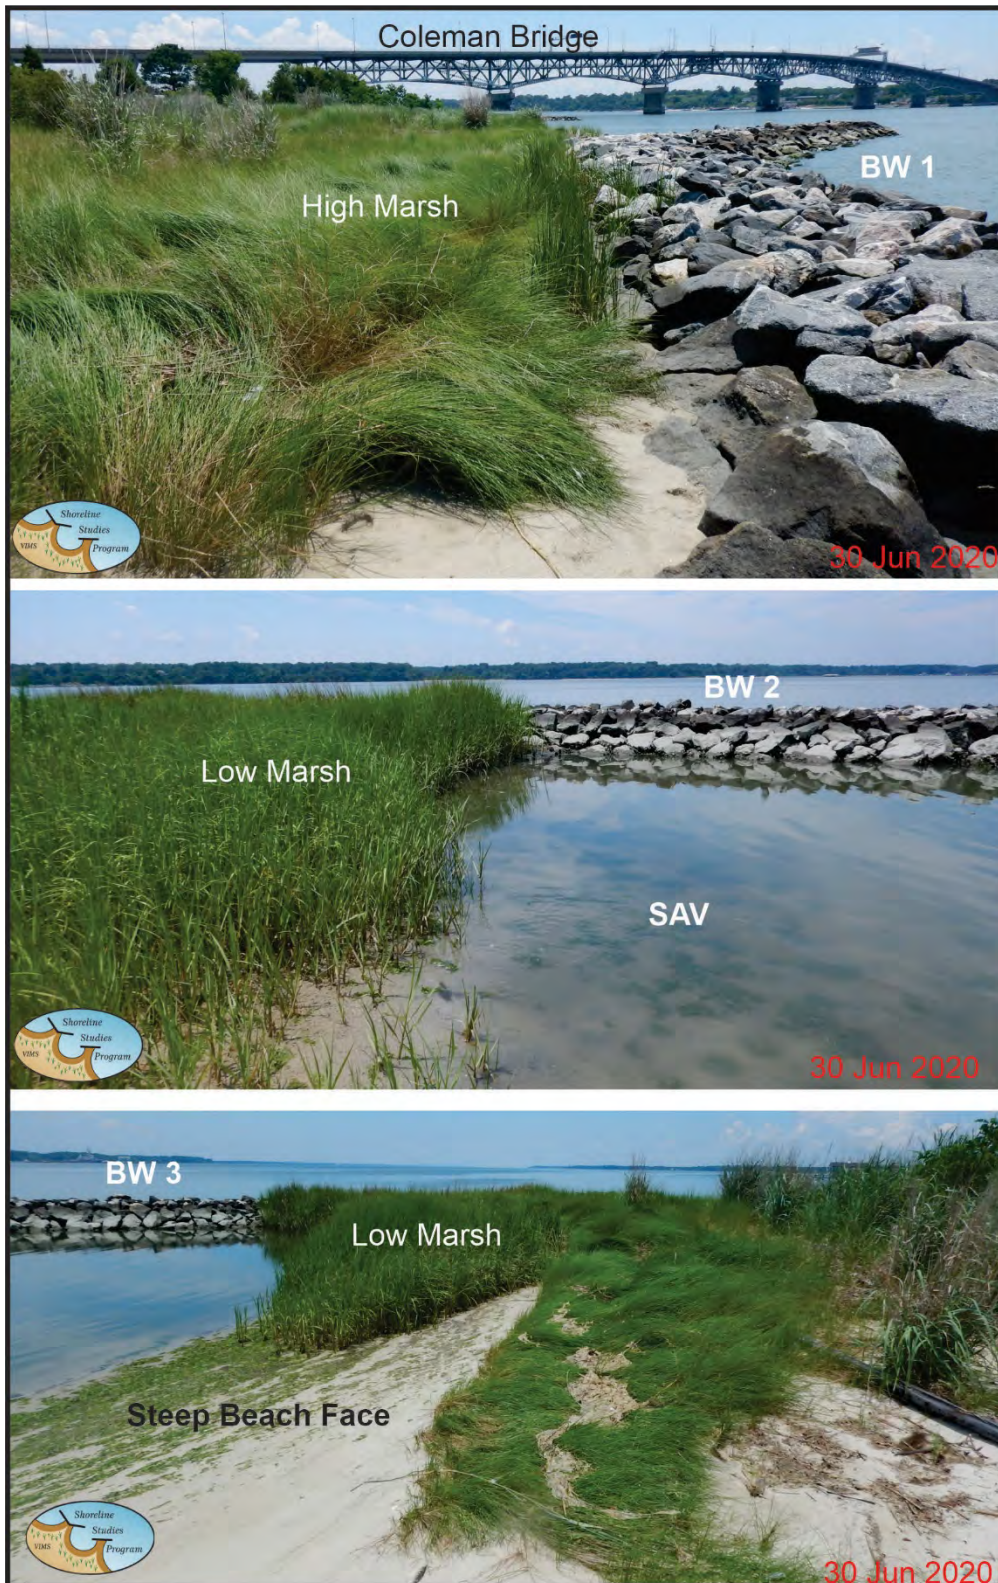
The vegetation is an important component of the shore protections system by providing substrate stability. Both the high and low marsh at the site are very lush (Figure 6-18). The beaches in the embayments are relatively steep, and some shrubs have colonized in the backshore where beach grasses were planted. However, generally, the beach grasses are sparser than the high and low marsh grasses (Figure 6-19).

Figure 6-18. State of VIMS West in June 2020 about 9.5 years after construction. The structures are stable and the high and low marsh grasses are lush. SAV has colonized in the embayments. Photo credit: Shoreline Studies Program, VIMS.

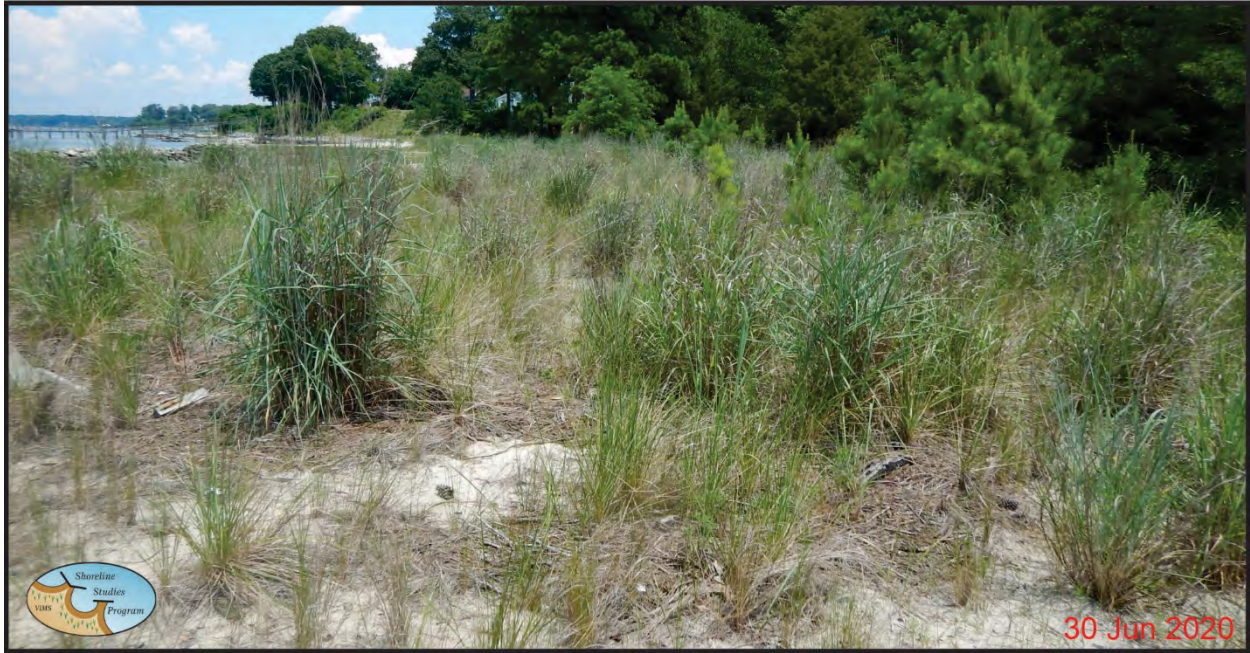
Figure 6-19. Backshore vegetation is sparser at VIMS West although some shrubs have colonized the area after 9.5 years. Photo credit: Shoreline Studies Program, VIMS.
