## 7 Werowocomoco National Park, Gloucester County

(Excerpt from "Living Shoreline Sea Level Resiliency: Performance and Adaptive Management of Existing Breakwater Sites, Year 3 Summary" Report)

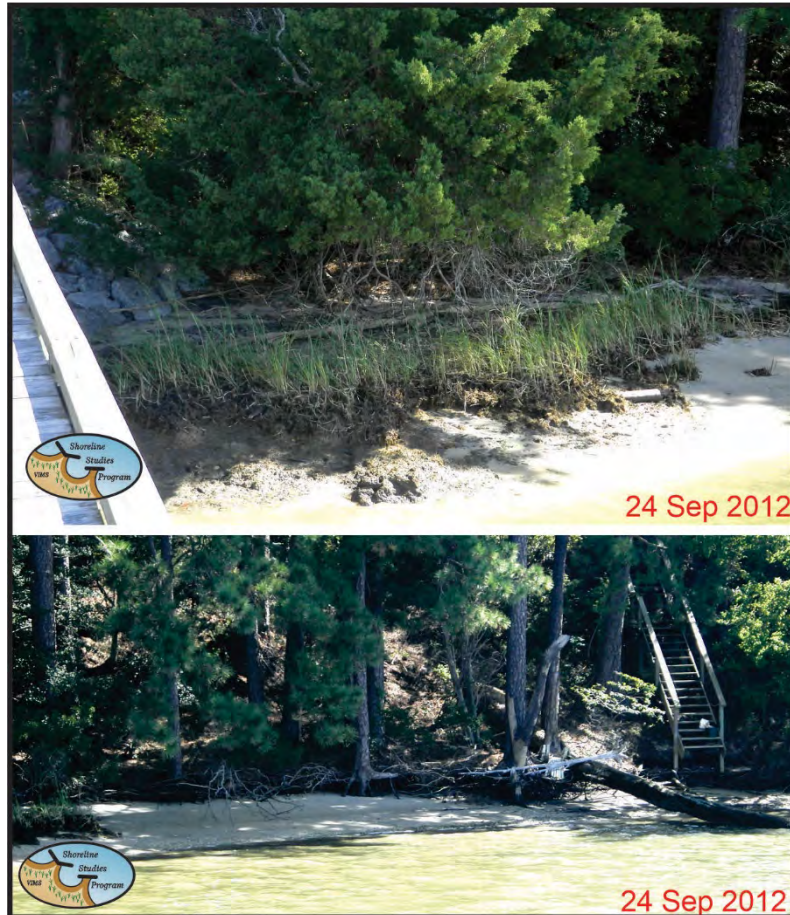
Several sections of the York River shoreline are protected with a high sill in front of the house and a revetment along the York River shoreline closer to Bland Creek. However, the section of shoreline near the pier was eroding into the bank (Figure 7-4). Great concern existed for the loss of high value archaeology associated with Powhatan and the Native American occupation of the site due to continued erosion of the bank in unprotected areas. This resulted in the construction of a stone gapped sill living shoreline system (Figure 7-1).

Figure 7-4. Werowocomoco shoreline and eroding upland bank in 2012. Very little of what used to be an extensive marsh fronting the upland bank remained, and the bank was being directly impacted by high water levels during storms. Photo credit: Shoreline Studies Program, VIMS.

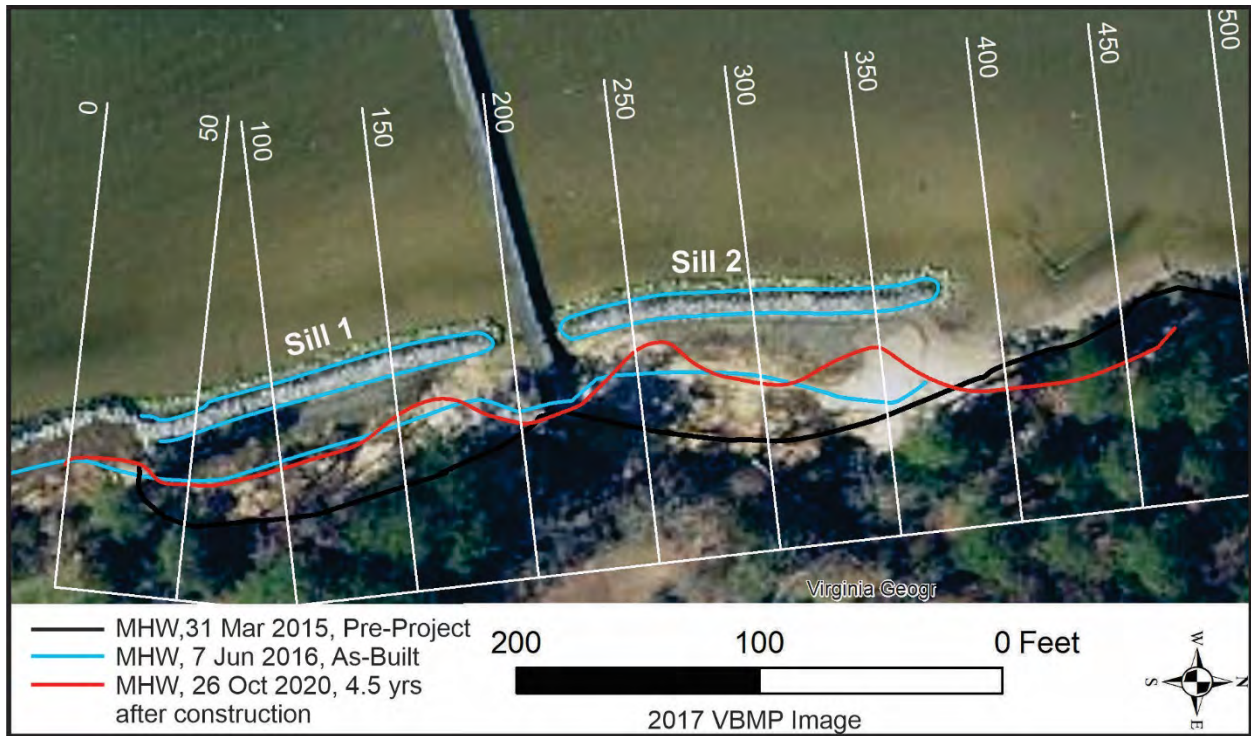
The site was surveyed before construction (31 Mar 2014), after construction (7 Jun 2016), and on 26 Oct 2020, more than 4 years after installation (Figure 7-8). The mean high water (MHW) line advanced riverward due to the placement of sand for the project. Most areas behind the sill have maintained the sand. The riverward advances on the Sill 2 are due to placement of additional sand after the as-built survey. The sand placed in front of the revetment at the pier has shifted. Of note, the shoreline north of Sill 2 is continuing to erode. Additional structures are needed to protect this section of shoreline (Figure 7-9).

Figure 7-8. The survey baseline and profiles at Werowocomoco. Also shown is the surveyed mean high water line at each of the survey dates.

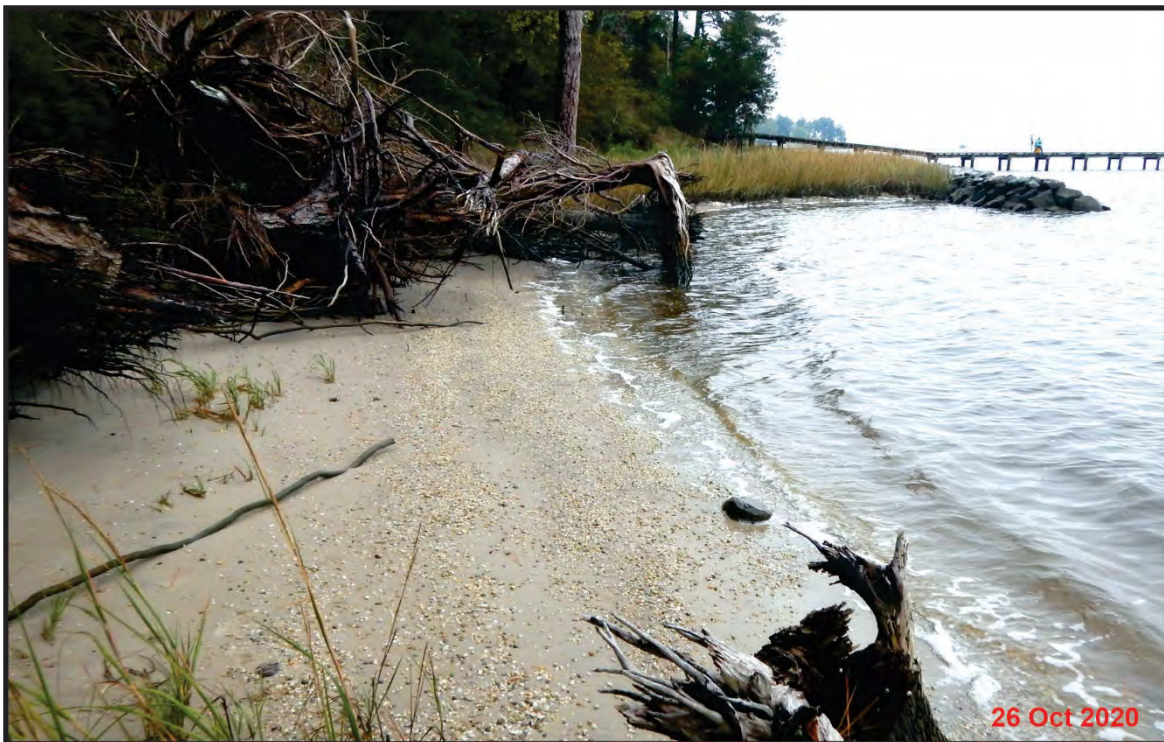
Figure 7-9. Eroding shoreline north of Sill 2. An additional structure is needed to protect the bank along this section of shoreline. Photo credit: Shoreline Studies Program, VIMS.

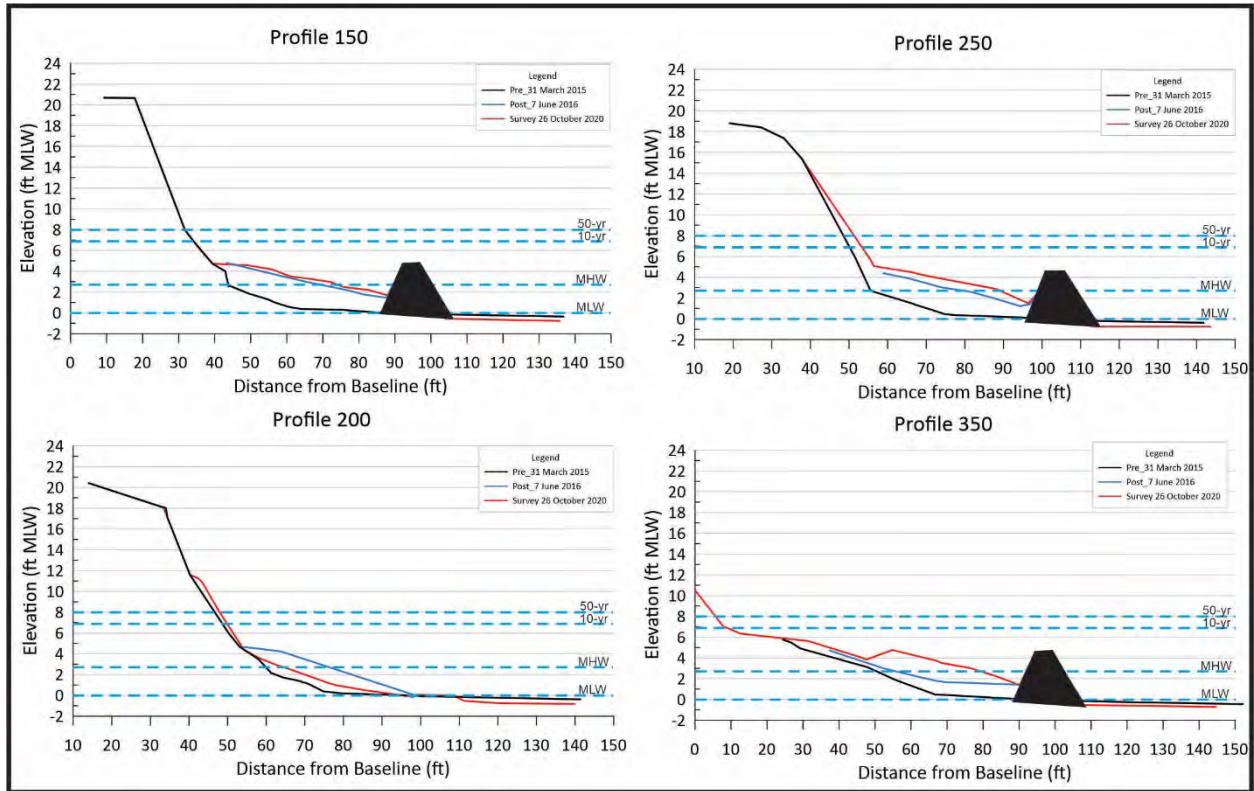
Figure 7-10 shows the cross-sections of the shoreline. Profile 150 shows that very little change has occurred since installation. At profile 200, which occurs between the structures, some of the sand fill has been eroded in front of the small, existing rock revetment. Sand was dumped over the bank on both sides of the pier so that the machinery could access the shoreline. This was done in lieu of grading to protect the existing archeology. Both profiles 200 and 250 show that sand was placed farther up the bank to facilitate access. Some additional sand was placed at profile 350 after the as-built survey occurred.

Figure 7-10. Profiles at Werowocomoco living shoreline pre-project, as-built and about 4.5 years later.

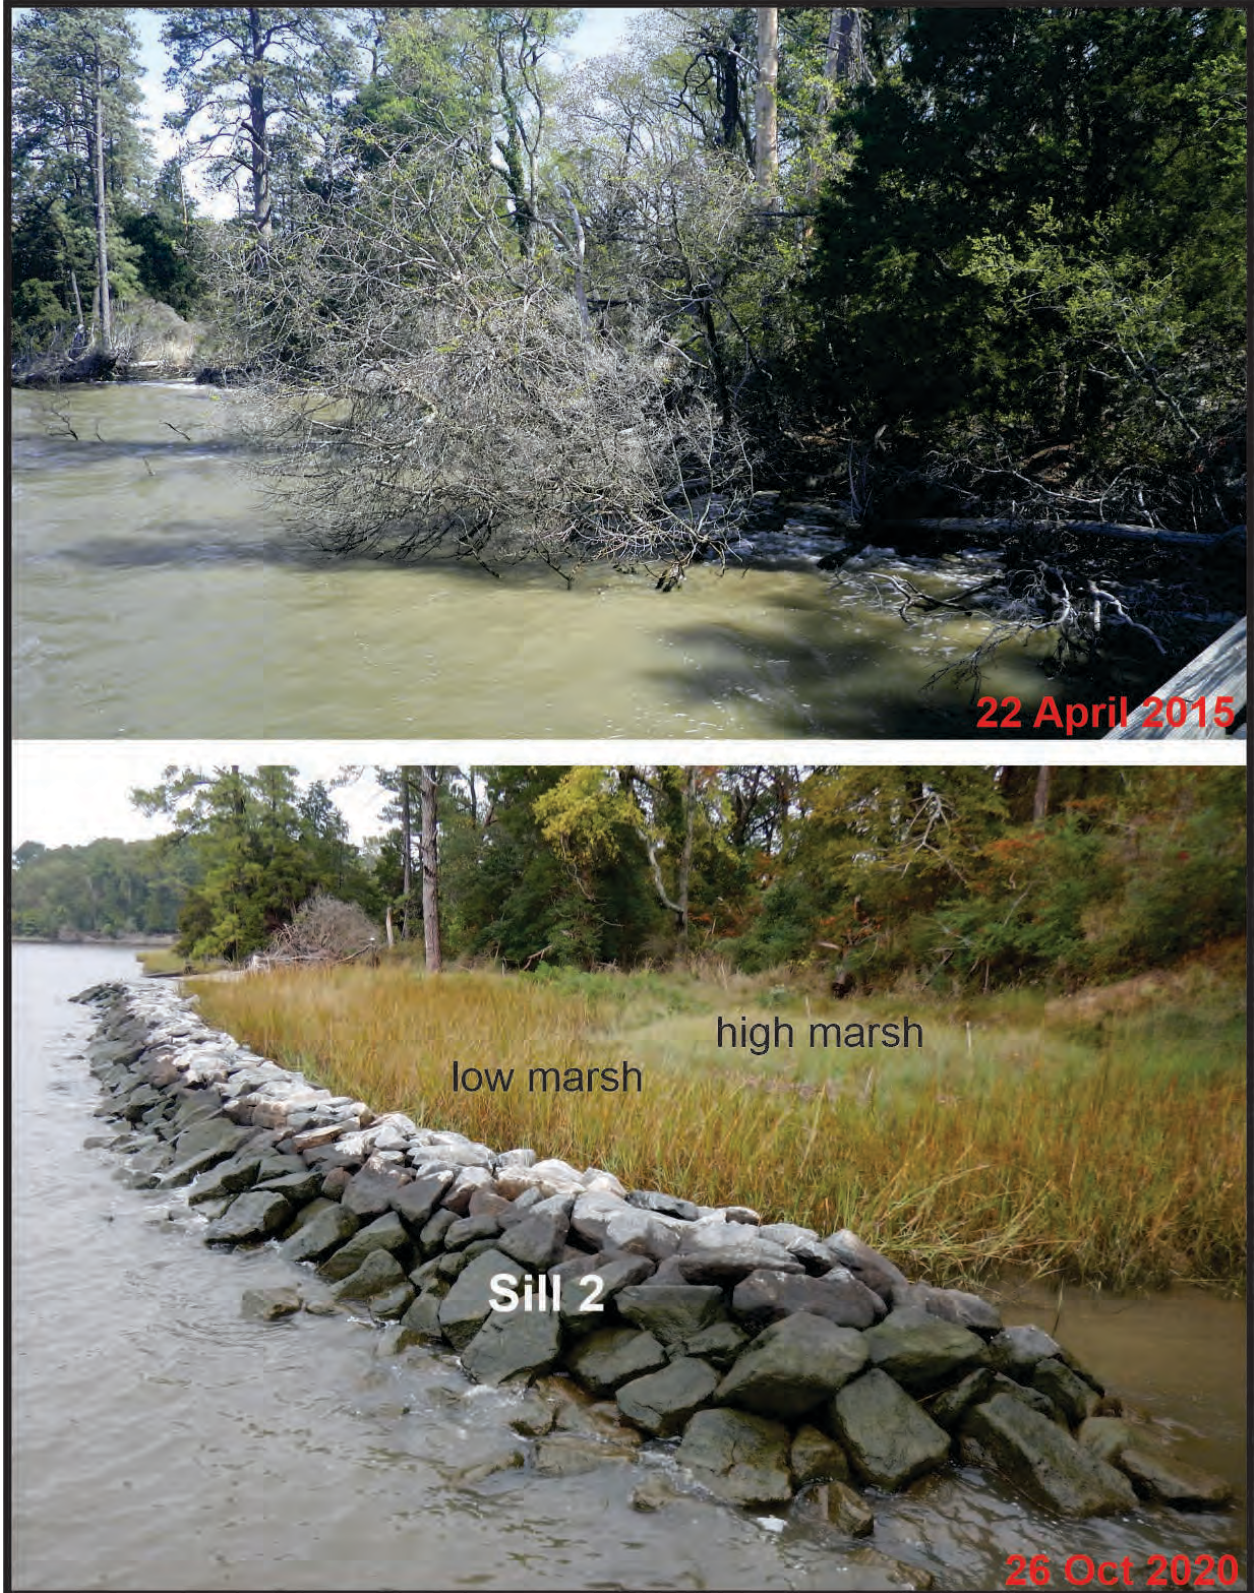
Since installation, this living shoreline project is functioning as expected. The eroding shoreline now has a wide high and low marsh behind the sills (Figure 7-11 and Figure 7-12) except for in the small embayment at the pier, which is beach. A well-established, lush marsh occurs from the back of the sill to the base of the bank. The sand was placed on a 12:1 slope which is slightly gentler than many other sills in Chesapeake Bay. This increased the width possible for the marsh, which in turn provides more wave reduction during storms and reduces wave impact on the upland bank. This southwest facing shoreline provides an extremely suitable area for marsh growth.

Figure 7-11. Pre-project shoreline showing an eroding bank with fallen trees (top); and Sill 2 about 4.5 years after construction showing a lush marsh (bottom). Photo credit: Shoreline Studies Program, VIMS.

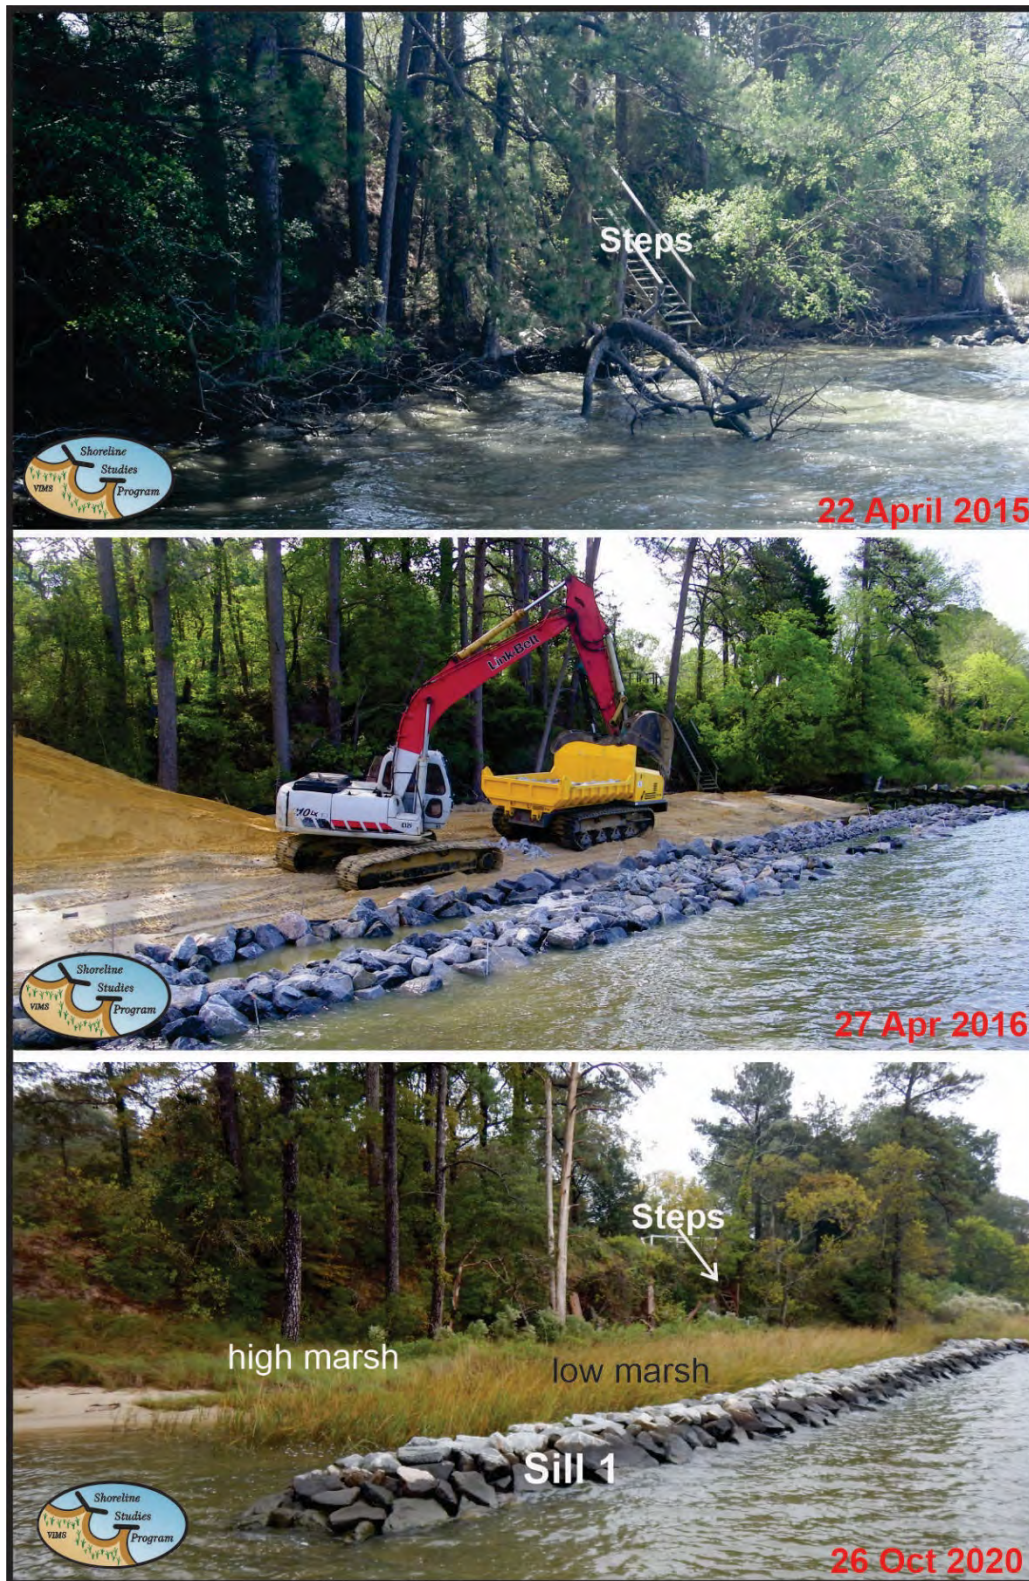
Figure 7-12. Pre-project shoreline showing an eroding bank with fallen trees (top); During construction of Sill 1 (middle); and Sill 1 about 4.5 years after construction showing a lush marsh (bottom). Photo credit: Shoreline Studies Program, VIMS.

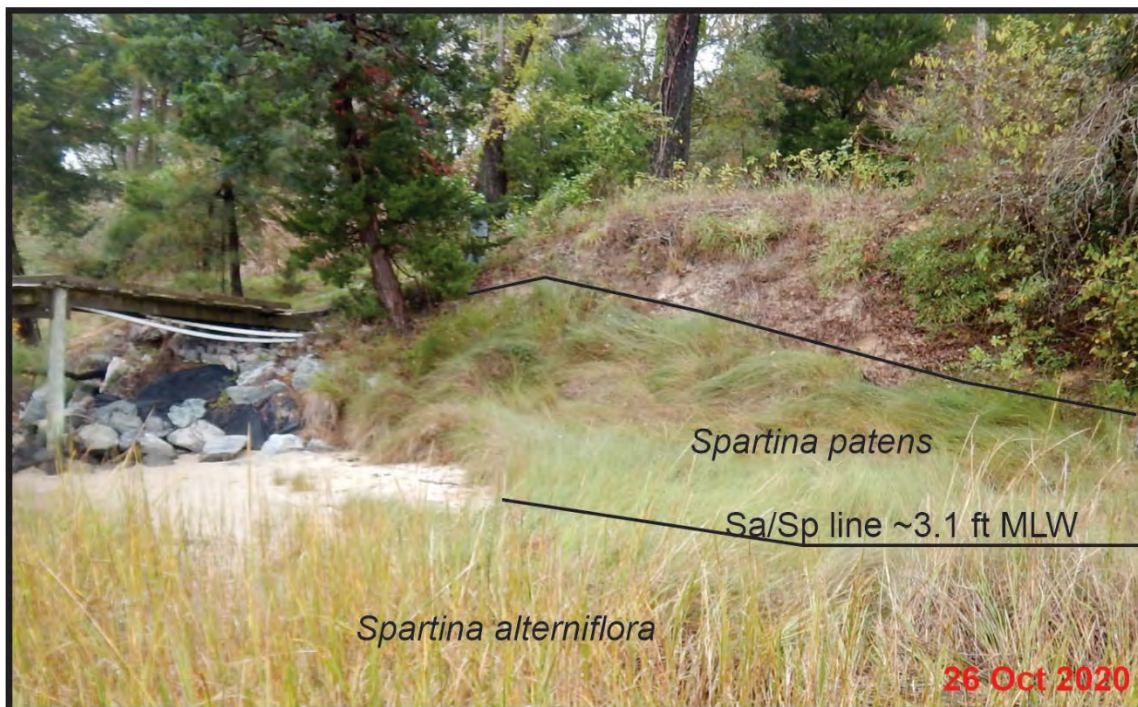
The site was only planted to mid-tide but now has filled in completely behind sill. Additionally, *S. patens* was planted up the slope of the upland bank where the sand was placed to provide access to the shoreline (Figure 7-13). It has done well growing up the slope. The survey also revealed that the approximate line between where *S. alterniflora* and *S. patens* were growing was at about 3.1 ft MLW in 2020 (Figure 7-14). This biologic benchmark is about the same as it was before the project was built, 3.2 ft MLW on the adjacent marsh shoreline.

Figure 7-13. Marsh behind Sill 1 about 4.5 years after construction. The *S. alterniflora*/*S. patens* biologic benchmark is similar to what it was pre-project. Photo credit: Shoreline Studies Program, VIMS.

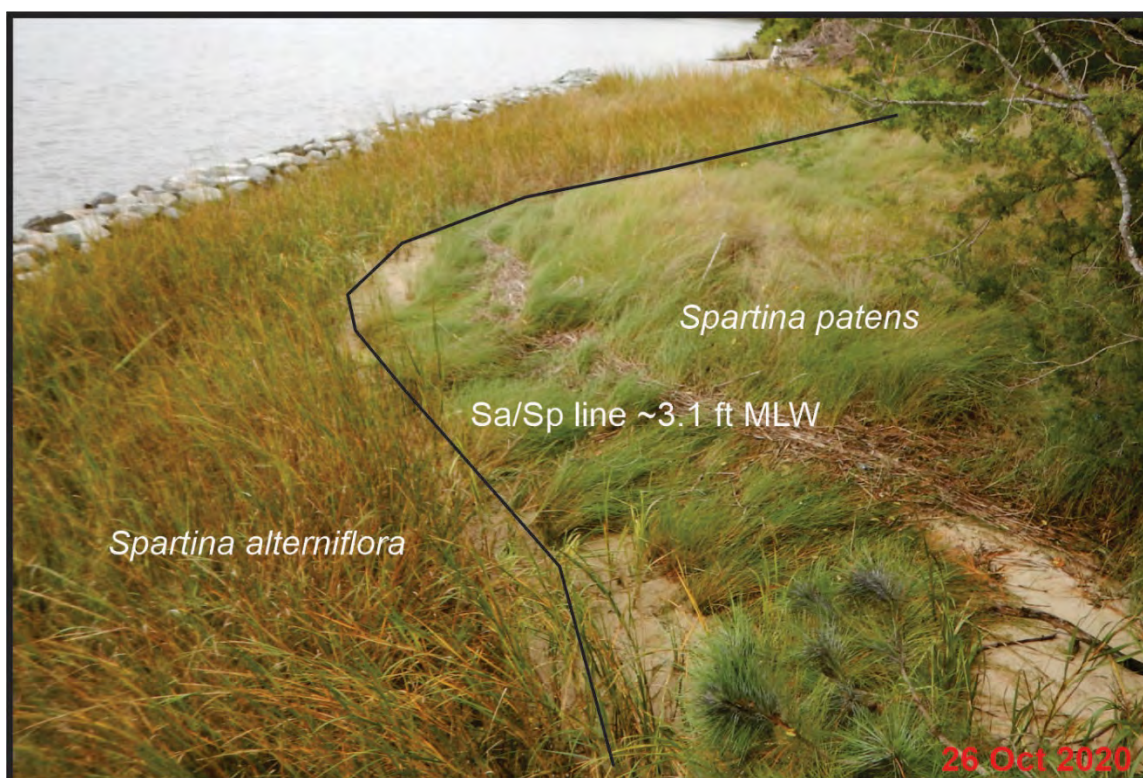
Figure 7-14. Marsh behind Sill 1 about 4.5 years after construction. The *S. alterniflora*/*S. patens* biologic benchmark is similar to what it was pre-project. Photo credit: Shoreline Studies Program, VIMS
