6 Virginia Institute of Marine Science-West, Gloucester County

(Excerpt from "Living Shoreline Sea Level Resiliency: Performance and Adaptive Management of Existing Breakwater Sites, Year 3 Summary" Report)

6.1 Site Background

6.2 Site Performance

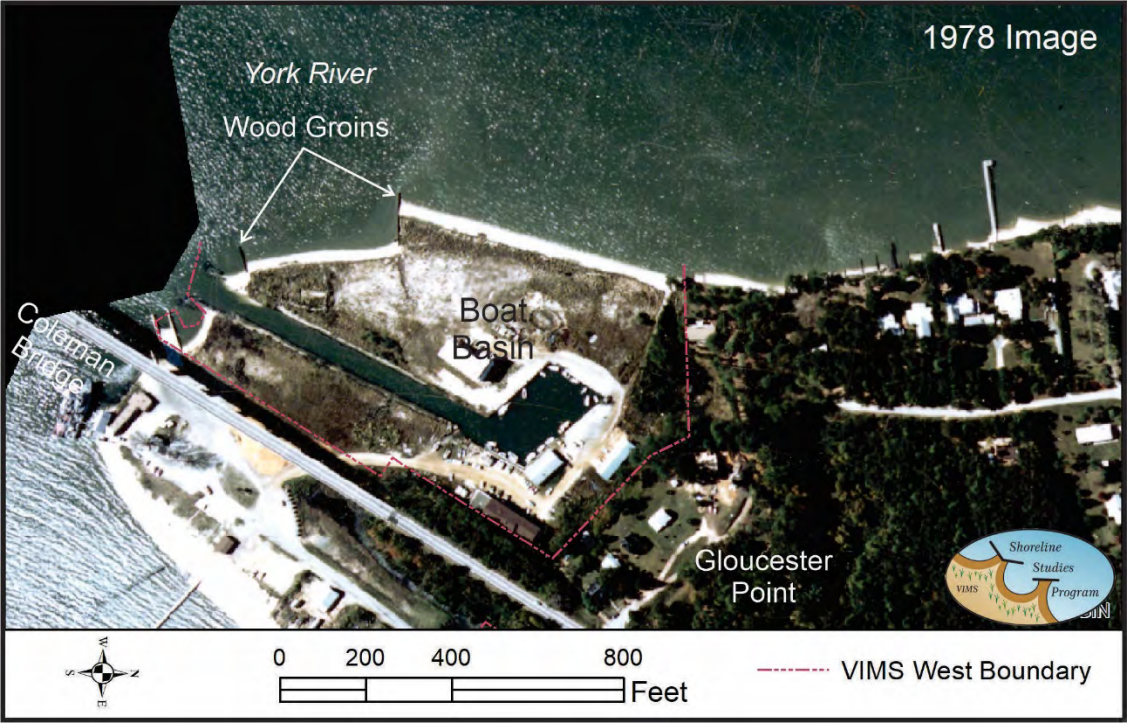
The transformation of Gloucester Point began in 1960 when the boat basin and entrance channel were dredged out from the existing tidal marsh and two small jetties were installed to secure the channel inlet (Figure 6-3). A long wood groin was installed on the shoreline sometime before 1978 along with a small groin just upriver of the boat basin entrance channel. The effect of these can be seen in 1978 aerial imagery (Figure 6-4). Sometime between 1978 and 1994, sand had accreted against the long wood groin, and sand was bypassing around the groin. Three short gabion basket breakwaters also were put in the embayed coast between the long groin and the channel entrance, the downriver reach. However, because sand was bypassing the wood groin, these small structures were completely covered in sand.

Figure 6-4. VIMS West shoreline in 1978 showing the present-day boundary of the VIMS West campus and the impact of two wood groins constructed along the shoreline (from Shoreline Studies Program shore change database).

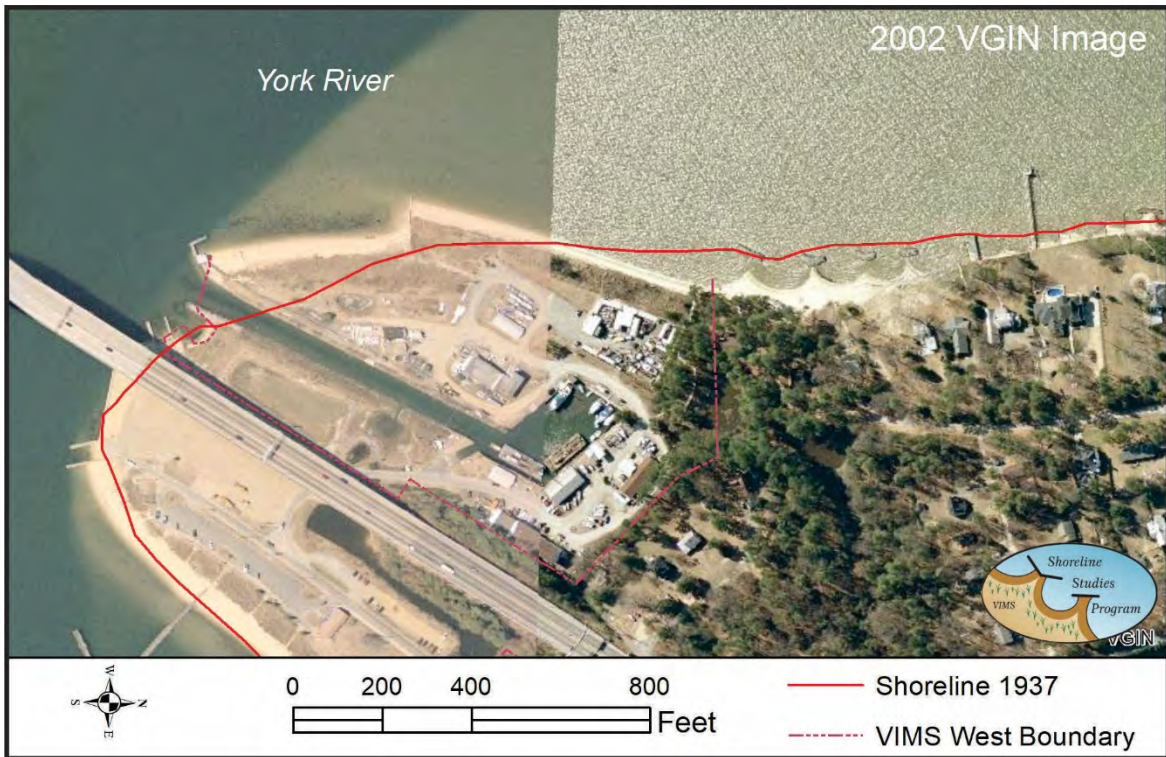
Since 1937, the upriver shoreline has been eroding while the downriver shoreline accreted. By 2002, the effects of upriver, updrift shoreline hardening and breakwaters resulted in a reduced beach near the upriver boundary of VIMS, but shore advance on the downriver reach (Figure 6-5). The VIMS west shoreline is impacted by a high energy regime. The shoreline faces west, and the fetch from the northwesterly direction is about 25 miles. During post-northeast storms, wind waves travel the length of the York River to impact this site. Tide range is 2.3 ft.

Figure 6-5. VIMS West shoreline in 2002 showing the present-day boundary of the VIMS West campus and the 1937 digitized shoreline (from Shoreline Studies Program shore change database). Over the years, many buildings were constructed around the VIMS boat basin and were impacted by storms.

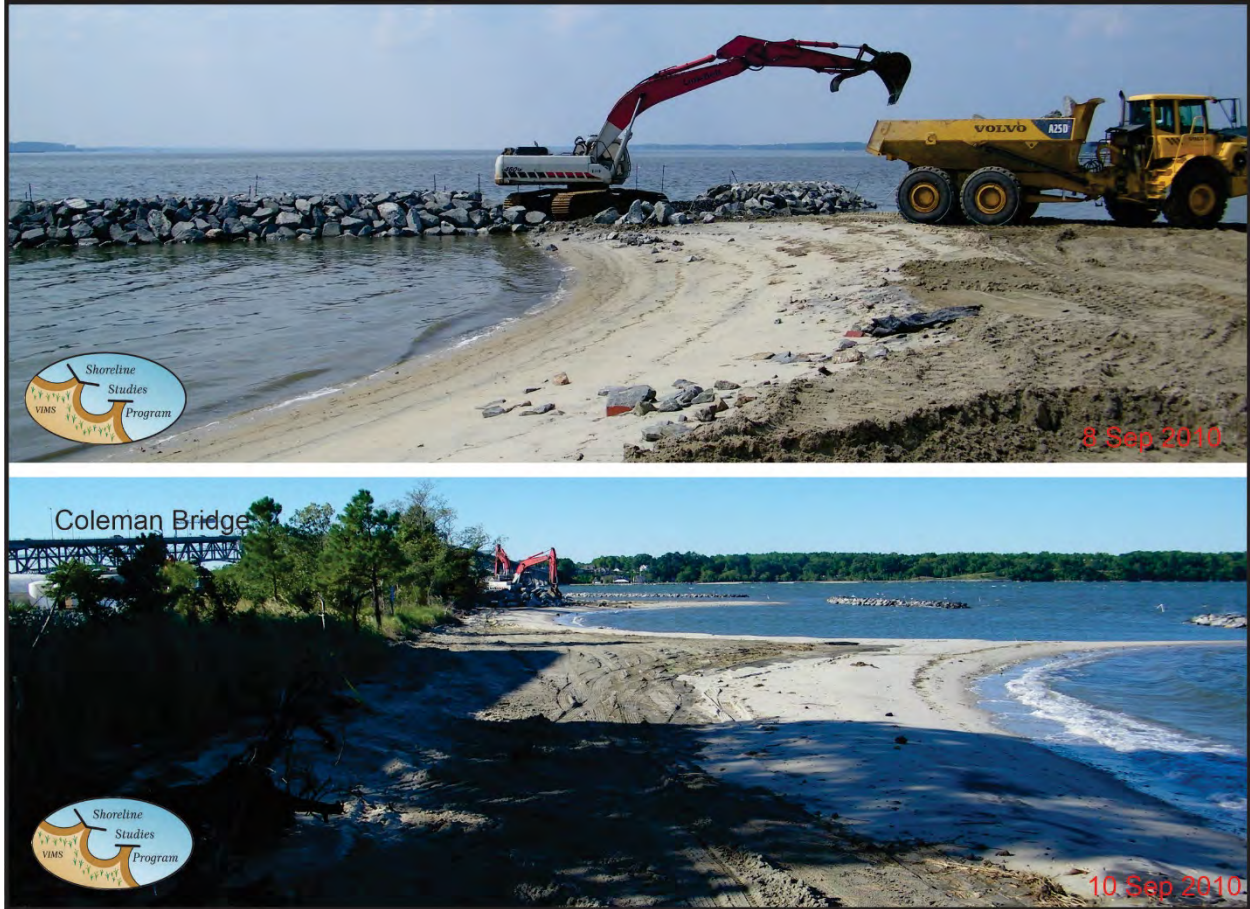
Figure 6-9. VIMS West shoreline during construction of the living shoreline in 2010. Photo credit: Shoreline Studies Program, VIMS.

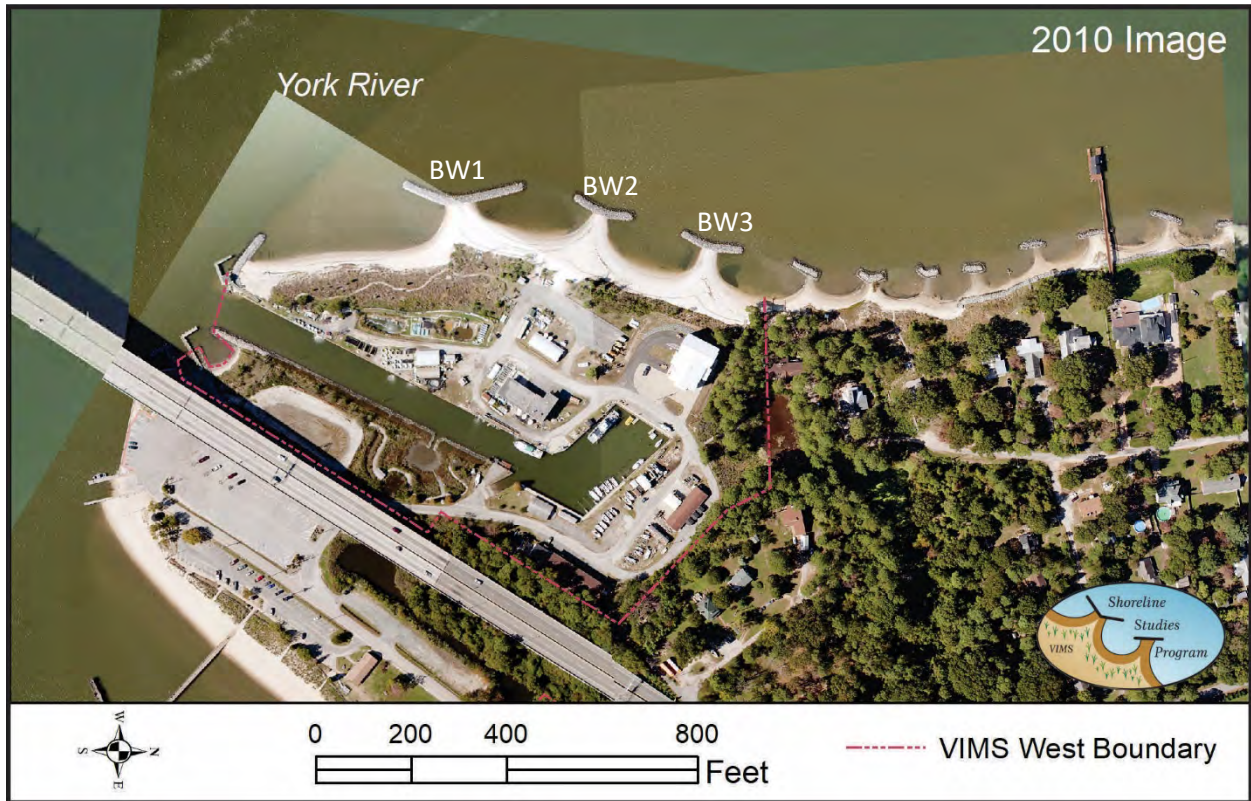
Figure 6-10. VIMS West aerial photo taken October 17, 2010 showing the newly constructed breakwaters and beach fill.

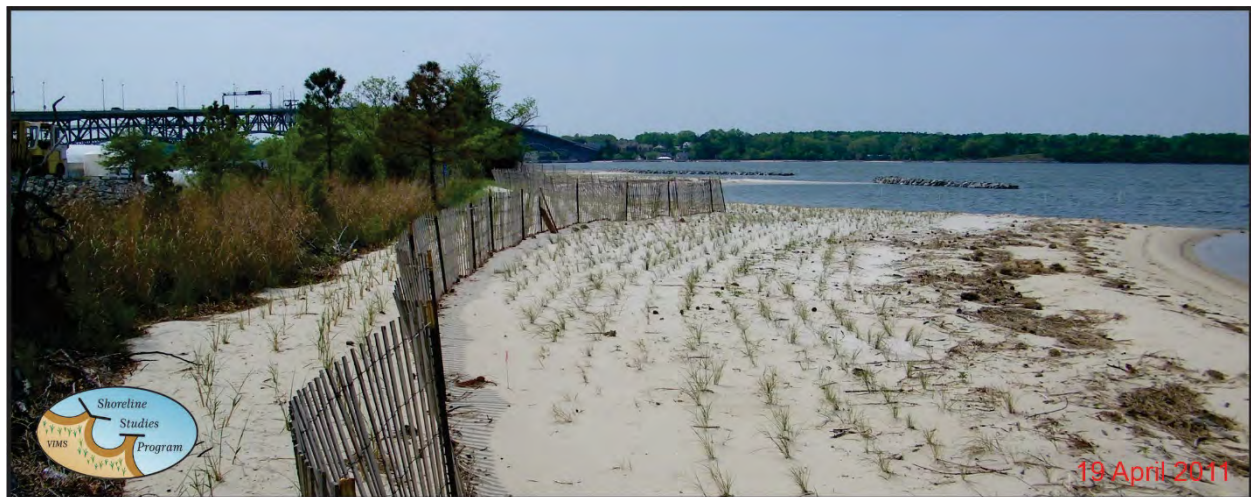
Figure 6-11. Planting of beach grasses took place the spring after construction. Photo credit: Shoreline Studies Program, VIMS
