## 7 Werowocomoco National Park, Gloucester County

(Excerpt from "Living Shoreline Sea Level Resiliency: Performance and Adaptive Management of Existing Breakwater Sites, Year 3 Summary" Report)

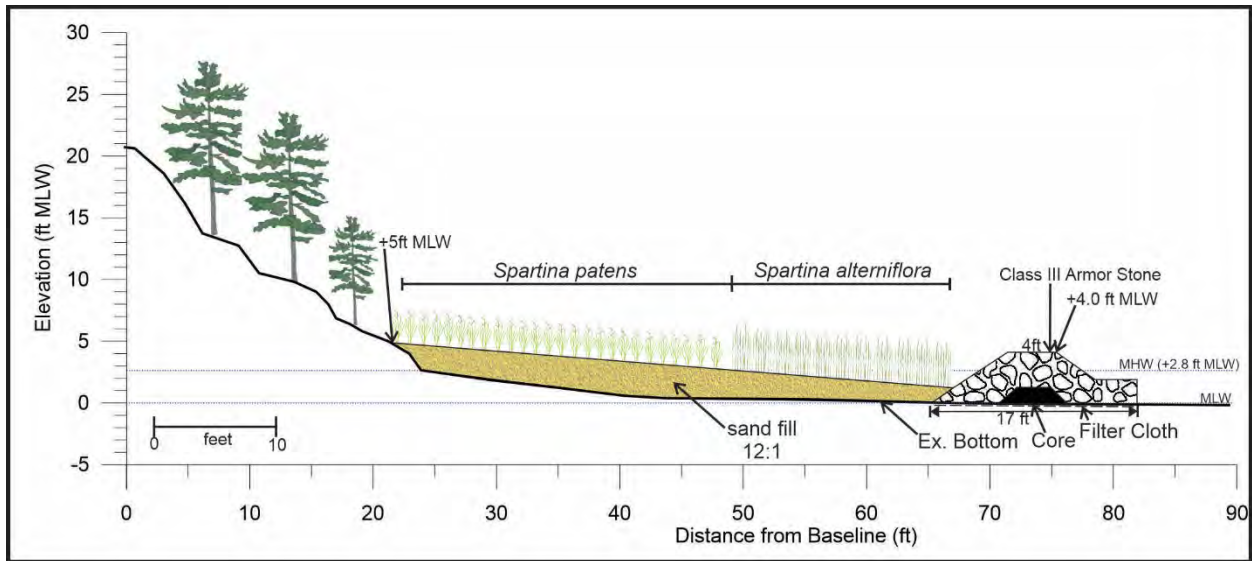
The Werowocomoco Living Shoreline project created/restored estuarine intertidal and riparian habitat, provided sustainable coastal hazards protection to a vulnerable historic resource, and provided the structure to mitigate the effects of sea level rise as well as sediment reduction to Chesapeake Bay. Two stone, gapped sills (152 and 170 ft long) with one window (25 ft wide) were constructed along 330 feet of shoreline (Figure 7-5). The southern sill (Sill 1) was attached to an existing higher, continuous sill. The upper elevation of sand fill was set at +5.0 ft MLW to interface with the eroding bank, and extended on a 12:1 slope to about mean tide level at the back of the stone sills (Figure 7-6).

Figure 7-6. Typical cross-section of the sill and sand fill at Werowocomoco living shoreline project.

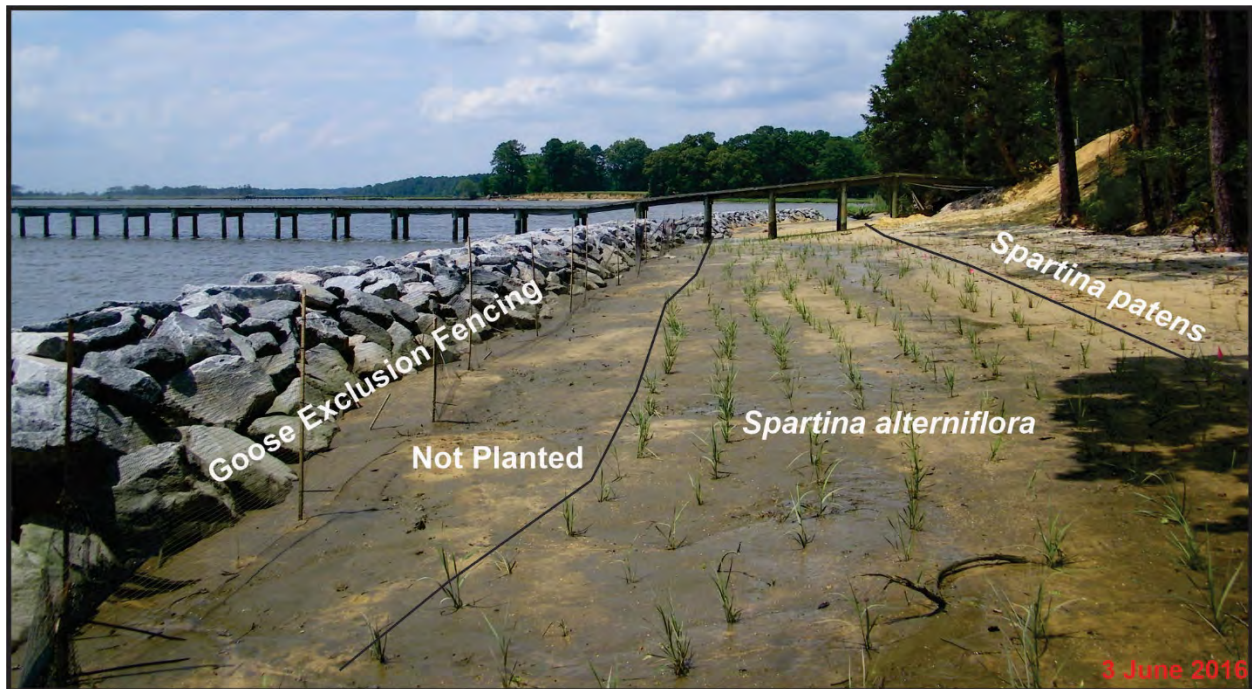
After installation, the placed sand was allowed to adjust for about 2 weeks. Soon after, approximately 15,000 square feet of *Spartina alterniflora* (low marsh) and *Spartina patens* (high marsh) were planted in May/June 2016 to create marsh habitat (Milligan et al., 2016). The grasses were planted on a 2 ft grid, and Osmocote fertilizer was put in the hole at time of planting (Figure 7-7). Generally, the grasses were planted from mid-tide to the base of the bank,

Figure 7-7. Planting zones of low and high marsh grasses. The sand equilibrated for about two weeks after it was placed. Photo credit: Shoreline Studies Program, VIMS.
